ABRAHAM LINCOLN BIRTHPLACE
MEMORIAL BUILDING

HISTORIC STRUCTURE
REPORT

Cultural Resources, Southeast Region
National Park Service

January 2001

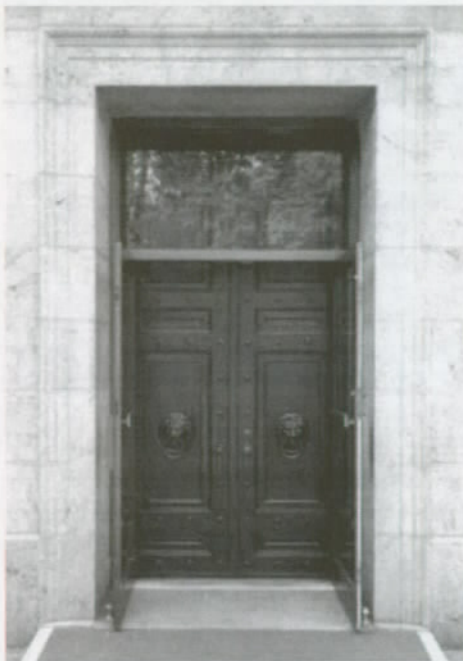
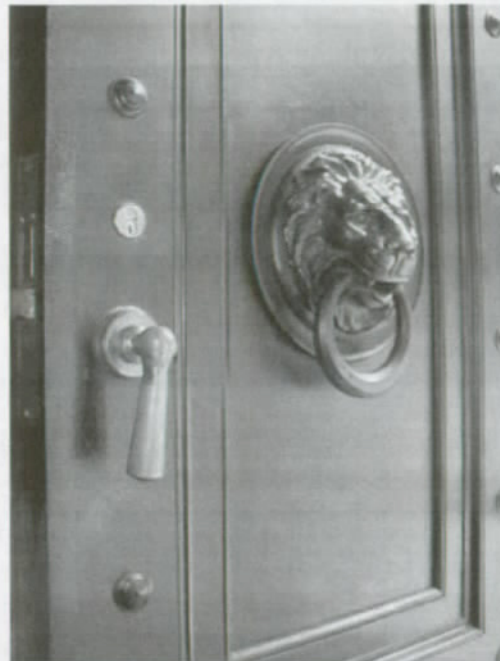
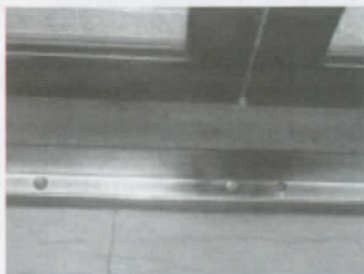
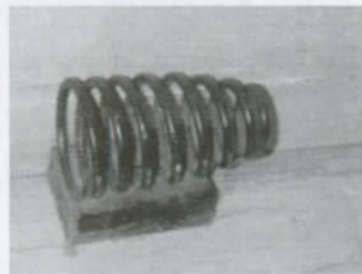
Exterior Door Unit: Bronze

DEFICIENCY: Uneven and dull black coating on bronze doors; north door is out of plum causing serious ware on threshold; non-historic aluminum store-fronts at both south and north entrances are inappropriate for building.

FEATURE DESCRIPTION: Outer: bronze colored aluminum store-front, double size with transom above (rated N) ; Inner: heavy bronze (rated H)
FEATURE NOTES: Basement: arched top metal frame - painted.(rated H); Plenum space above interior ceiling: heavy bronze (rated H)
FEATURE CONDITION: GOOD
HISTORIC RATING: H/N
TOTAL INVENTORY: 5 EA

RECOMMENDATION: Restore the original appearance of the bronze (reddish-golden brown patina); Rehang north door to eliminate ware on threshold; Relocate handicapped access button from surface of north door; Remove bronze colored aluminum store-front and door at south and north entrances and replace with total glass system.

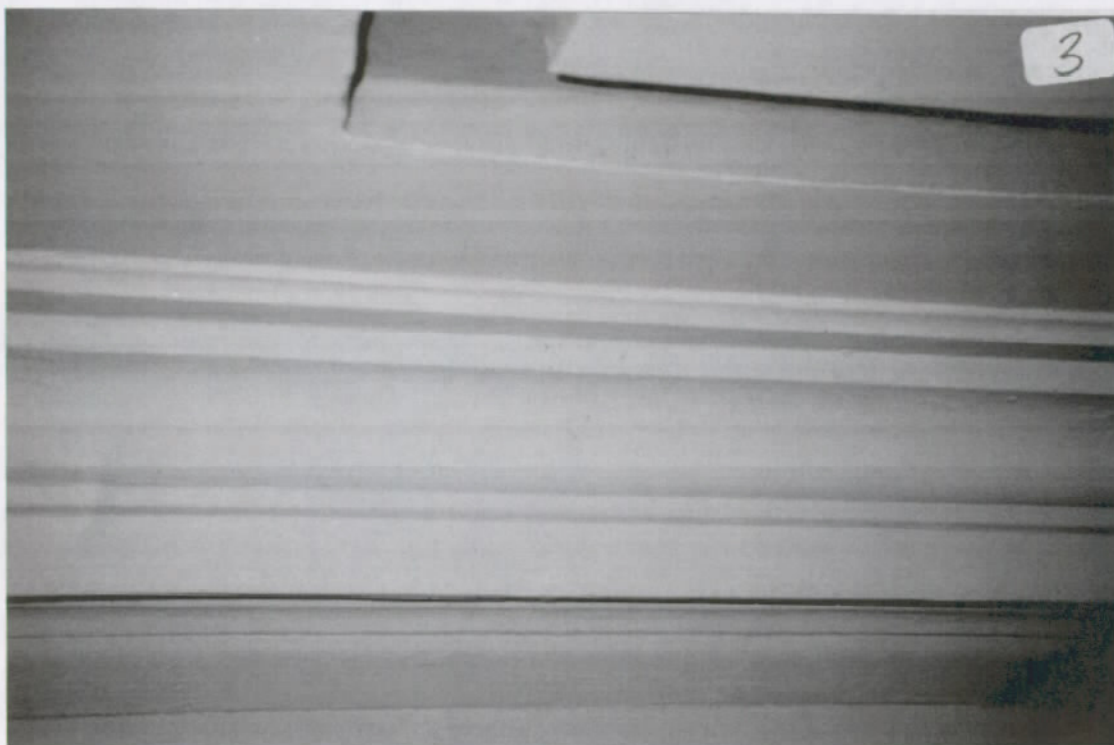
Figure 3. View of crisp profile of cornice which has not been repaired, or, if repaired, was done using a proper template.

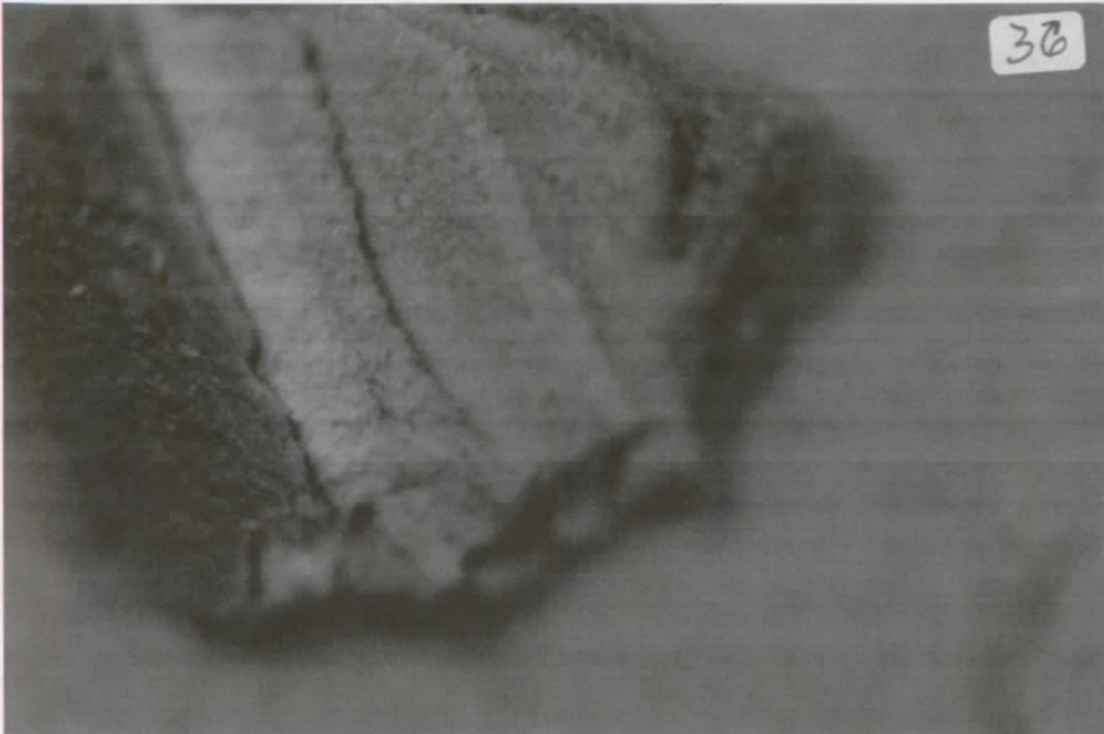
Figure 12. Photomicrograph of small cross section of paint with darkest blue showing at left. Shows thick white coating under blue, then two other blues, then pale soft rosey cream, gray, stone colors.
